Pen Argyl Borough Weona Park Swimming Pool

WALLOVER ARCHITECTS *incorporated*

July, 2006

Swimming Pool Feasibility Study Final Report

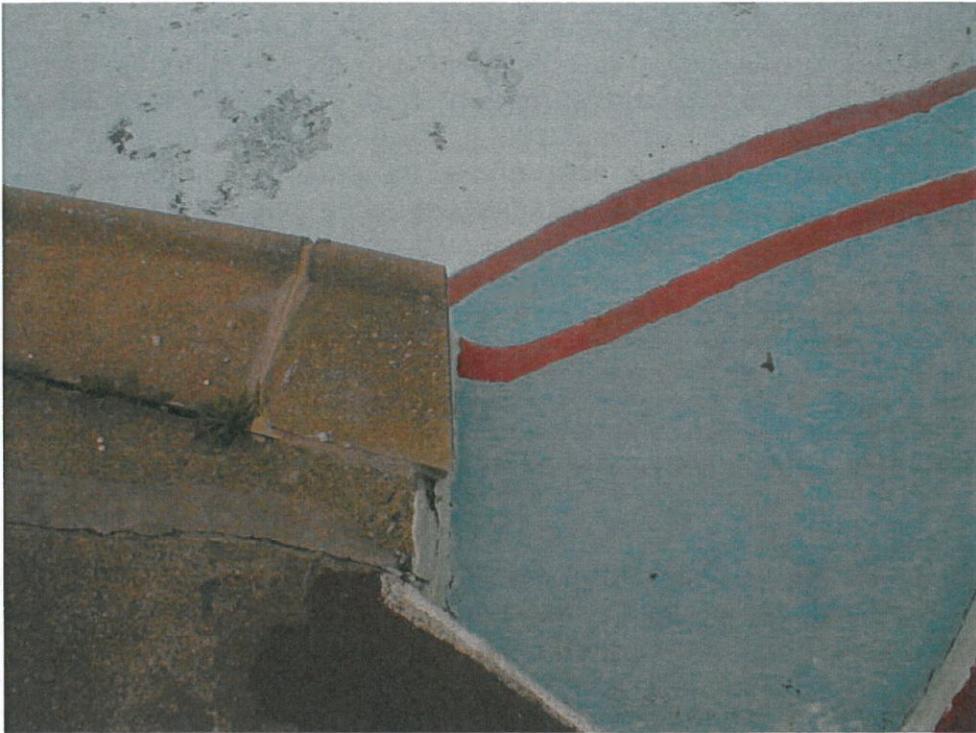
The main and tot pools include precast concrete copings surrounding both pools. The painted finish is in poor condition exhibiting significant pitting where raw concrete is exposed. Skimmer outfalls (41) around the tot and main pools provide limited removal of surface water and accumulated debris. Two main drains provide the only bottom drainage in both pools. Filtered water return is via two

bottom piping runs in the main pool and a piping run at the base of the wall in the tot pool. The tot pool is filtered through the main pool system, which is also in violation of current standards. Skimmer boxes for a pool of this width are not recommended in the ANSI / NSPI-1, American National Standard for Public Swimming Pools, 2003 (ANSI / NSPI), or the recently updated Pennsylvania Bathing Manual which has been replaced by the referenced ANSI / NSPI standards.

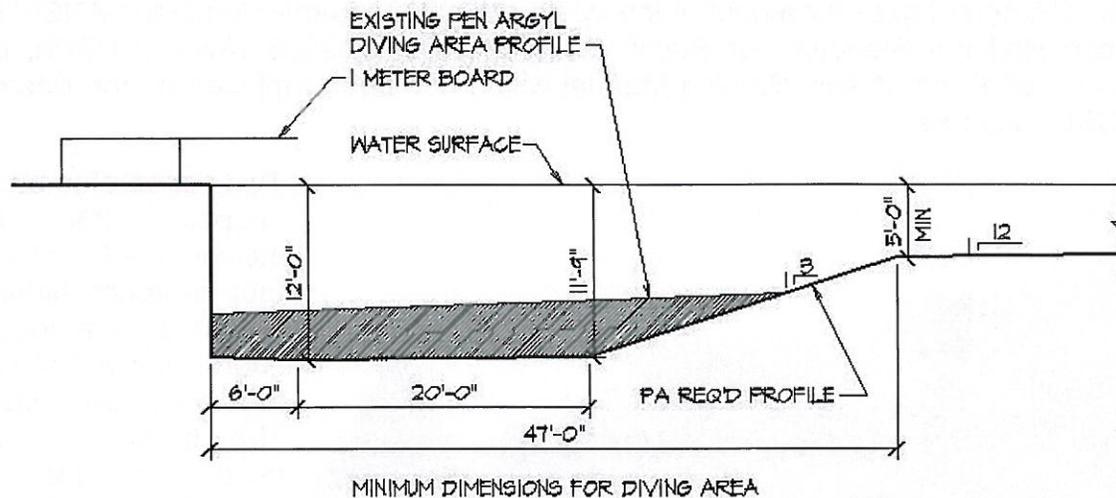
Diagram A

The total volume of the main pool structure is approximately 111,725 cubic feet. The water volume of the current main pool containment structure is approximately 835,702 gallons. The recreational area from 2'-10" to 5'-0" comprises 5,588 square feet of water surface area. The 12,982 square feet of water surface area from 5'-0" to 8'-10" represents two-thirds of the main pool and indicates that the main pool is largely a deep water pool. The deep end contains no diving well and does not comply with NCAA required diving well profiles. In the former location of the diving stands the depth at the plummet is not sufficient for a 1 meter diving stand (NCAA requires 12'-0" minimum). The former orientation of the diving boards faced northwest. The assigned diving area is approximately 8'-10" deep. As the current pool does not meet current design standards **diving from a 1-meter tower into any part of the pool is not recommended or advised.** (See Diagram A)

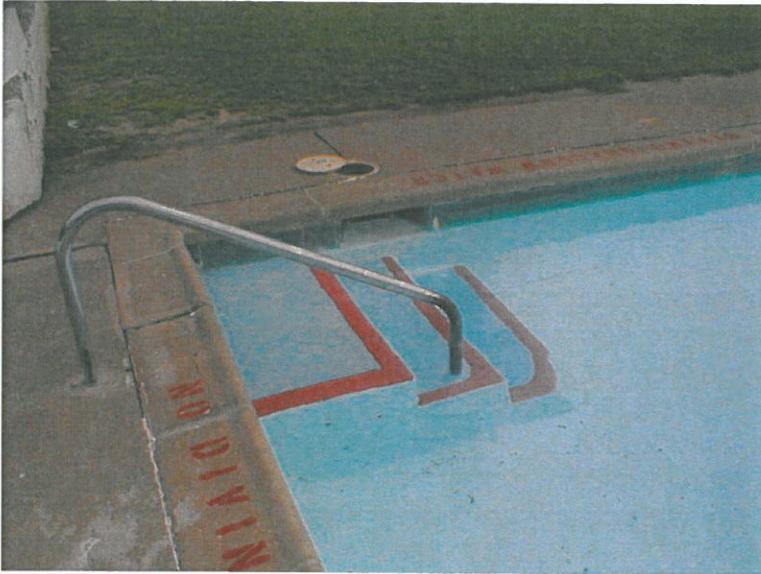
Walk-in steps with handrails facilitate access the main pool. The handrails are not an ADA compliant configuration. The minimum deck width is 4' around the main and tot pools with decks in excess of 20' behind the former diving board location. Decks are discontinuous around the tot pool area and as such are not in compliance with national standards. Significant cracking and tripping hazards were noted around both pool structures due to paving deterioration, etc.

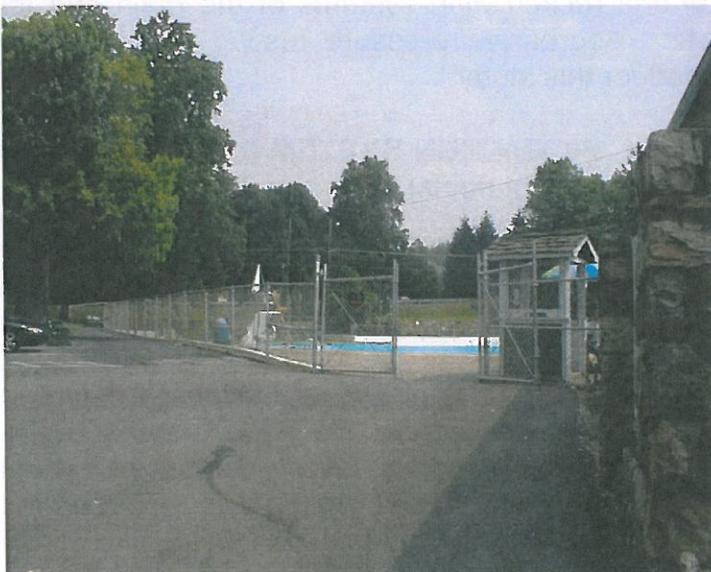
The entire pool site is enclosed with a 6' high chain link fence. This fencing is in fair condition and incorporates four gates of varying widths to provide access near the four corners of the enclosed area of the pool. Adequate lawn areas are adjacent to the pool along the north and west sides of the pools. The bathhouse, located directly east of the main pool's deep end is of rough rubble stone construction with access from the second level to the pool deck level from its main exit stairs.

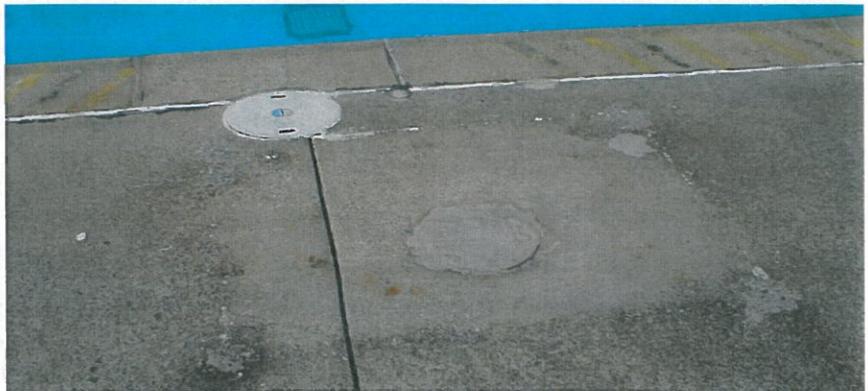
Skimmer pool designs are not capable of providing uniform skimming during quiescent periods nor are they capable of sustaining any significant surge loads. Also, the skimmer pool design is not legal for pools greater than thirty feet in width. Skimmer pools greatly increase daily cleaning and long-term maintenance costs.

Typical skimmer / deck condition:
