Pen Argyl Borough Weona Park Swimming Pool

WALLOVER ARCHITECTS *incorporated*

July, 2006

Swimming Pool Feasibility Study Final Report

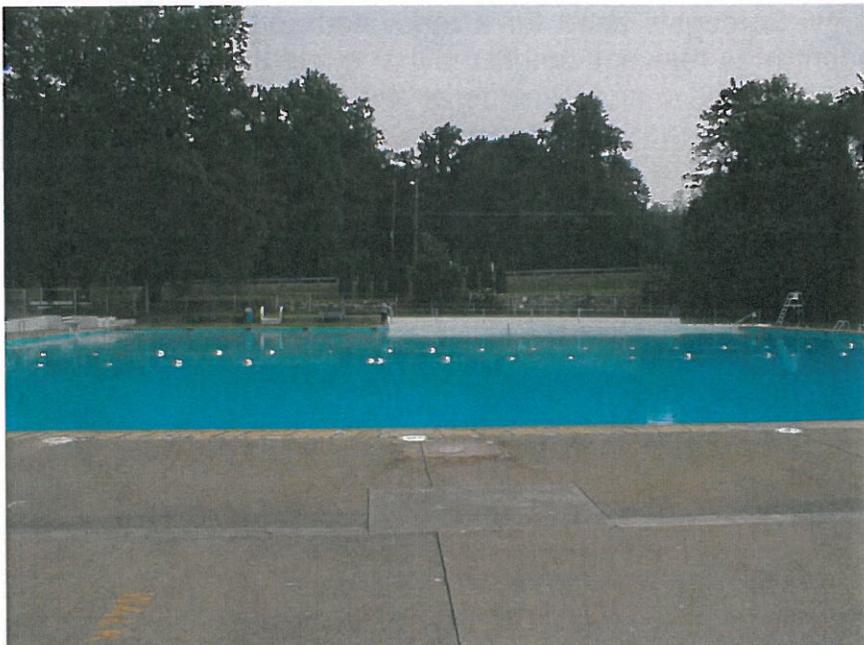
The Weona Park Pool began as a dammed up natural drainage area that was used as the Park's "swimming hole". The Borough built an unfiltered "pump and dump" concrete walled, sand bottom pool on the site in 1926. The pool was renovated including a new filtration system and piping in 1967. The original concrete walls constructed in 1926 remained in place while a gunite concrete floor and additional concrete was added to the walls. The additional gunite added to the wall thickness concealed new filtration piping, encased new skimmers and supported new concrete decks surrounding the pool. A unique, river washed stone veneer bathhouse was added to the pool complex in 1934. The pool was again the subject of a renovation study in 1987. The study identified, some areas of repair, some of

which some were performed. In 1988 the filtration system was updated with filters being replaced, some piping components replaced, limited areas of concrete repair, new floor joints installed and repaired, and drain valves replaced. The history of the surrounding park complex is well covered in the Weona Park Master Plan, 2002.
